**CWA COMPLIANCE EVALUATION INSPECTION REPORT
U.S. ENVIRONMENTAL PROTECTION AGENCY, REGION 5**

Facility: Bischer Farms
6121 Purdy Road
Ruth, Michigan 48470

NPDES Permit Number: MI0057669

Date of Inspection: 08/28/08

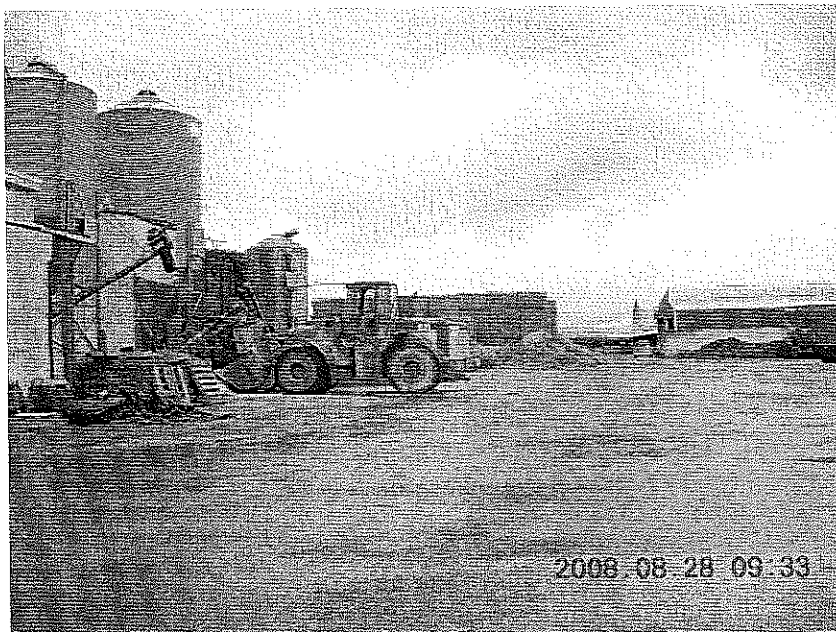
Photo 1 (DSCN 3940)

Description: Paved pad underlying East Sector production area. Graded to the south (left).

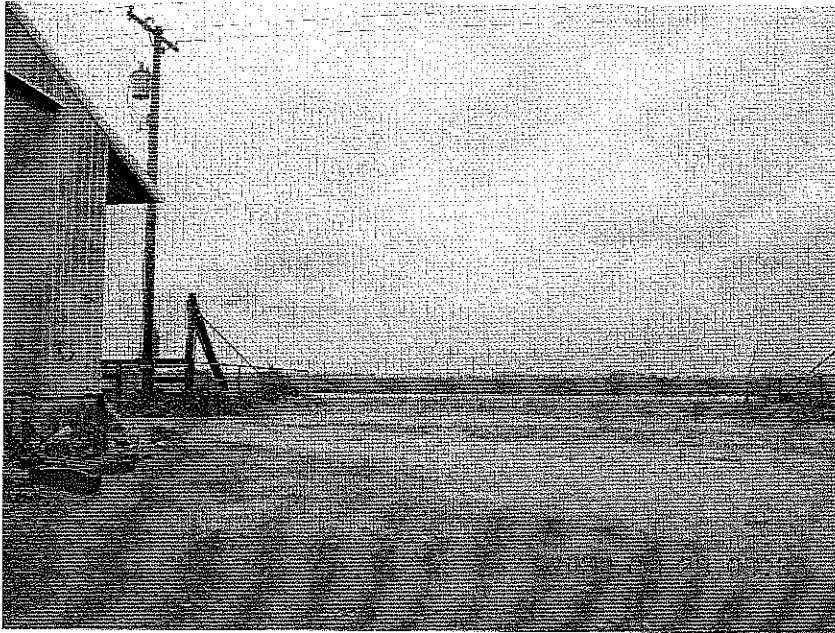
Photo 2 (DSCN 3941)

Driveway runs over the roadside ditch, and is elevated to prevent runoff from paved pad (foreground).

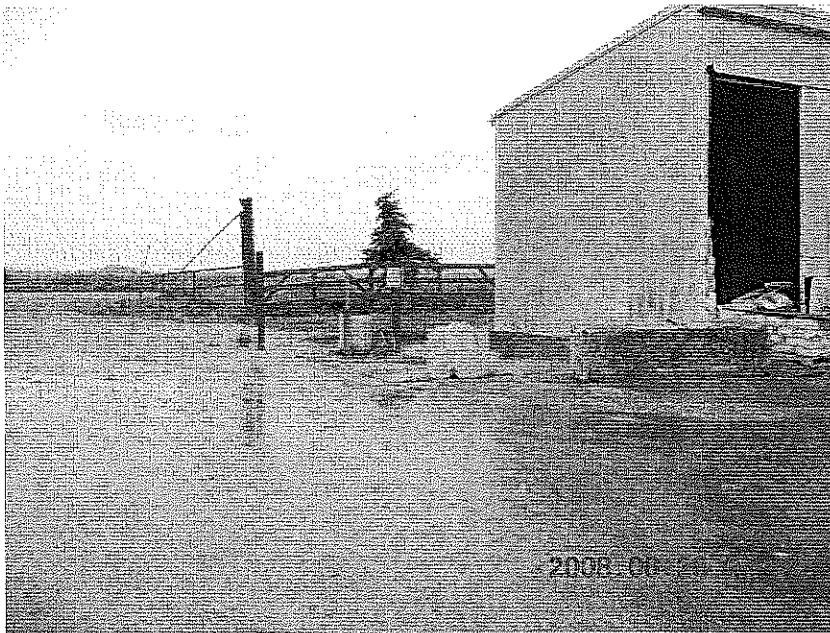
Photo 3 (DSCN 3942)

Description: Catch Basin No. 2 at the south border of East Sector paved pad.

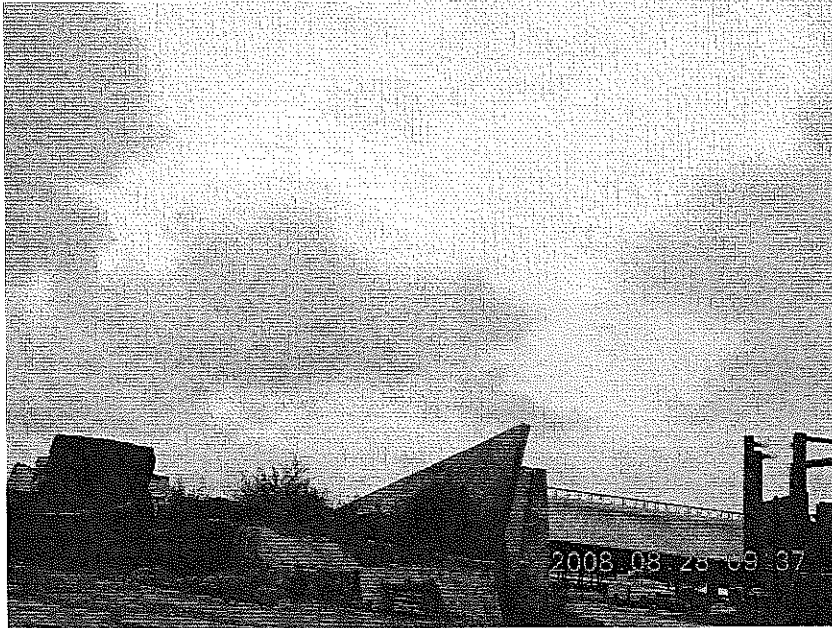
Description: West side of Little Barn (Little Barn location indicated on map, Attachment A).

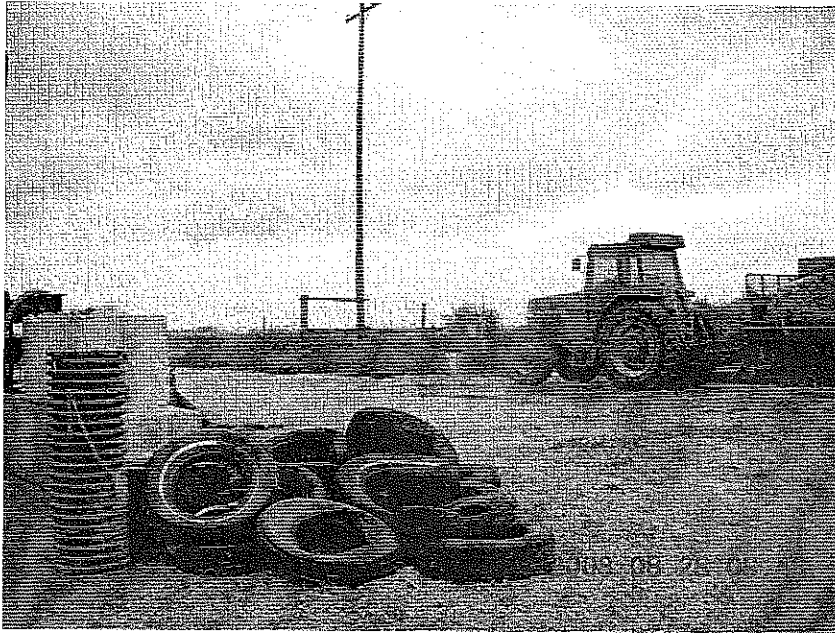
Photo 8 (DSCN 3949)

Description: Catch Basin No. 3 (to left of tractor) at the southwest corner of the paved pad underlying East Sector production area.

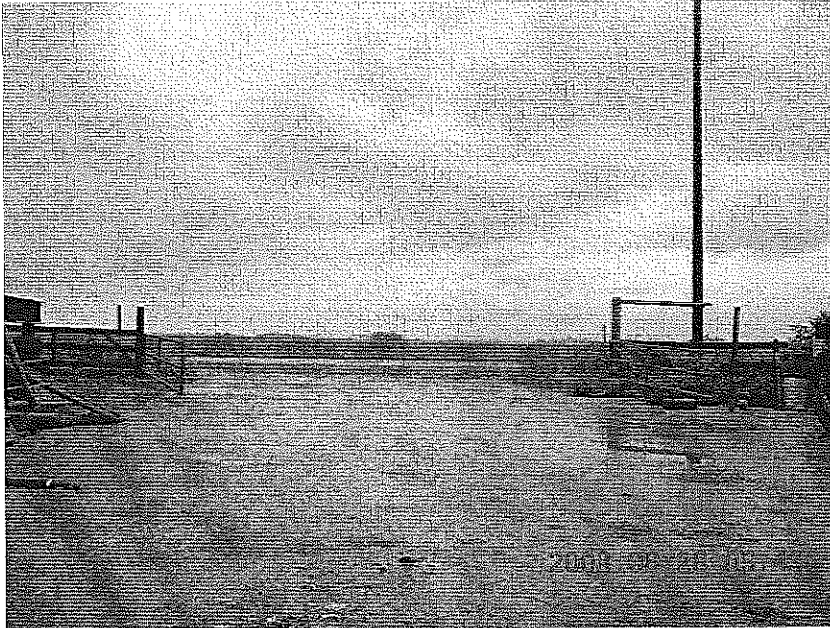
Photo 9 (DSCN 3950)

Description: Driveway No. 2 crossing roadside ditch from Purdy Road. Driveway No. 2 is elevated to prevent runoff from paved pad (foreground). Catch Basin No. 3, right.

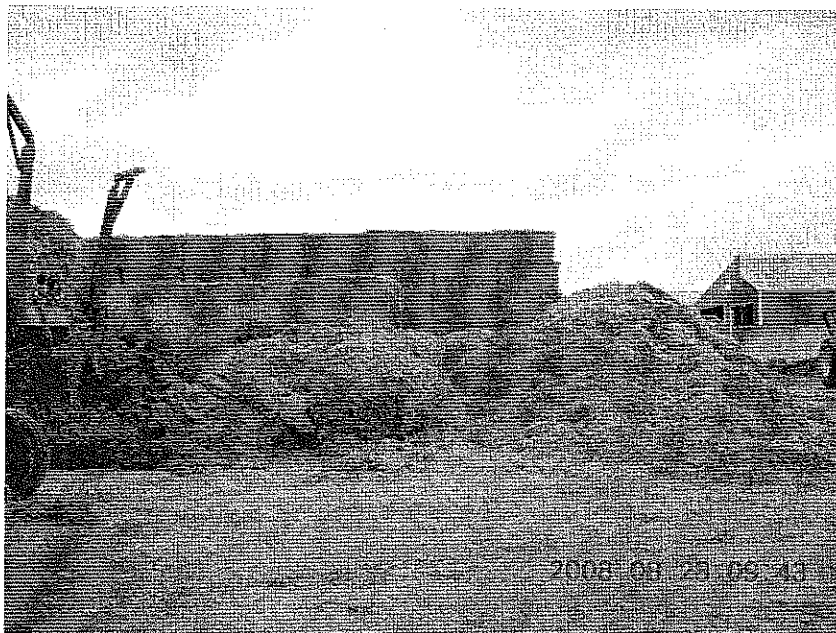
Photo 10 (DSCN 3951)

Description: Close-up of silage located on paved pad in East Sector, foreground, and haybales, background. Silage and hay leachate runs into four catch basins located on south border of pad (to the left in the photograph).

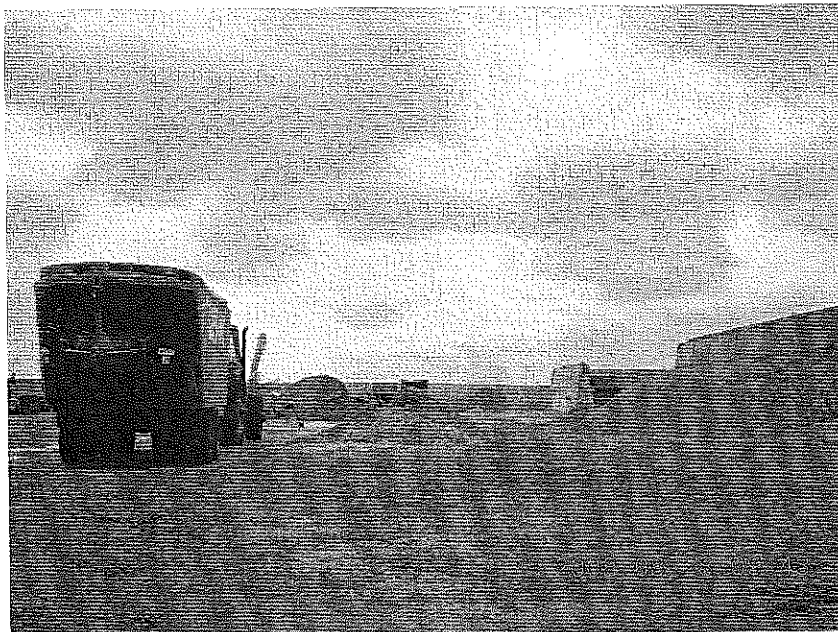
Photo 11 (DSCN 3952)

Description: Silage located on paved pad in East Sector. Leachate runs into four catch basins along south border of pad.

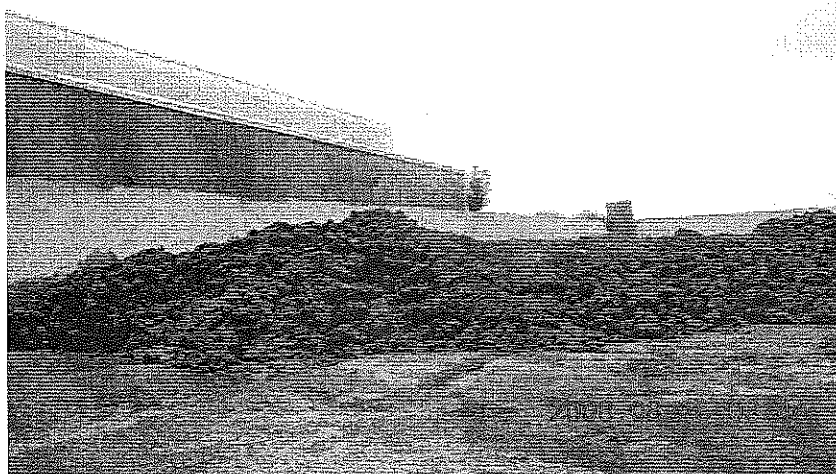
Photo 13 (DSCN 3957)

Description: Manure solids on East Sector paved pad. This solid manure is collected from Red Barn, New Barn, Hospital Barn, and Little Barn (Barn locations indicated on map, Attachment A).

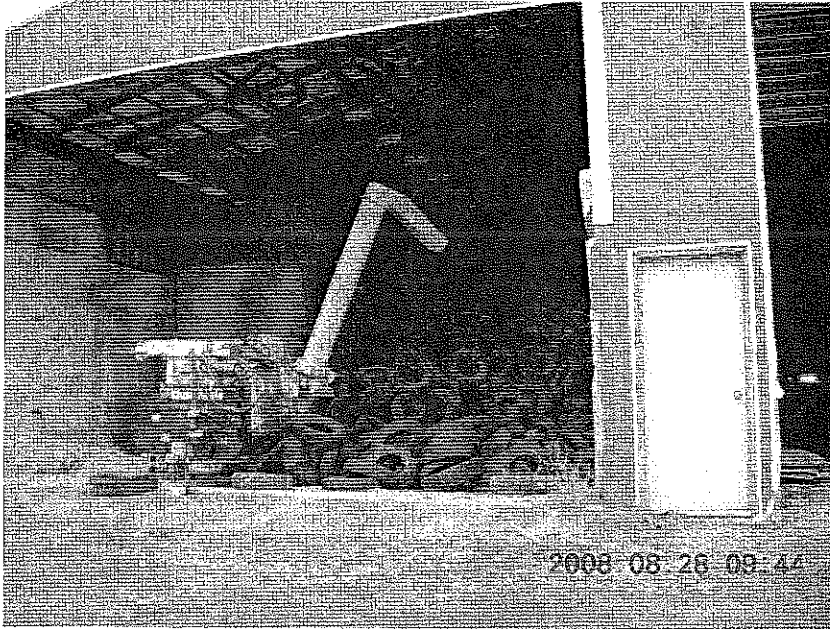
Photo 14 (DSCN 3958)

Description: Commodity Barn (aka Tire Barn) and liquid manure pump, left, located on the west side of the East Sector paved pad. Tracked silage and hay, foreground. Leachate from tracked silage and hay flows to four catch basins to the south of the East Sector paved pad.

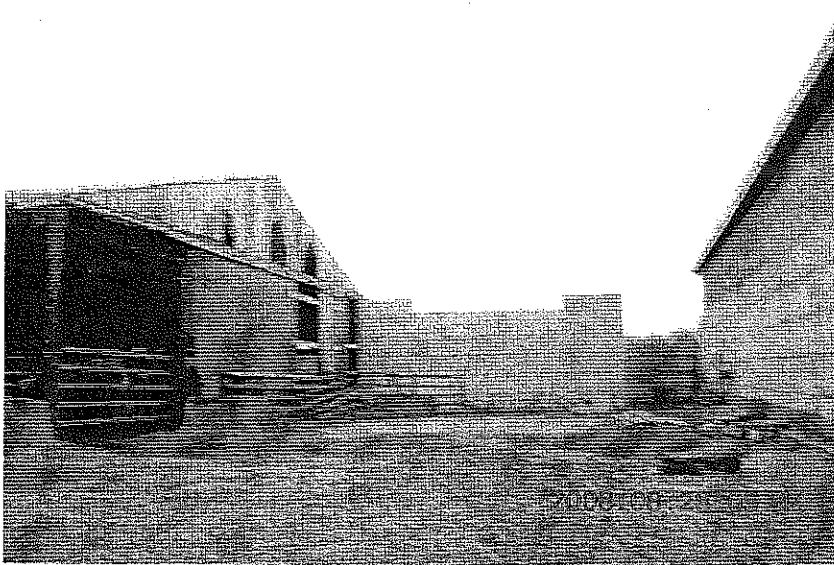
Photo 16 (DSCN 3960)

Description: Red Barn, left. Commodity Barn, right. Concrete compost storage, center. Leachate from compost storage flows into Catch Basin 5, located behind the compost storage structure. Tracked silage and hay, foreground. Leachate from tracked silage and hay flows to four catch basins to the south of the East Sector paved pad.

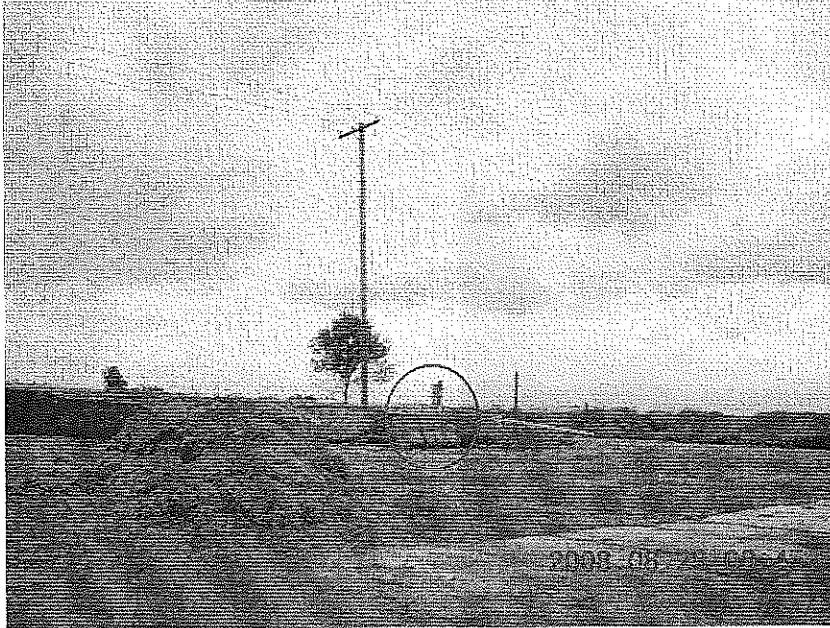
Photo 17 (DSCN 3964)

Description: Southwest corner of East Sector paved pad. Driveway No. 1, indicated by green arrow, connects the East Sector paved pad to Purdy Road. Driveway is elevated to prevent runoff into roadside ditch that runs between the paved pad and Purdy Road. Catch Basin No. 4 indicated by pink circle.

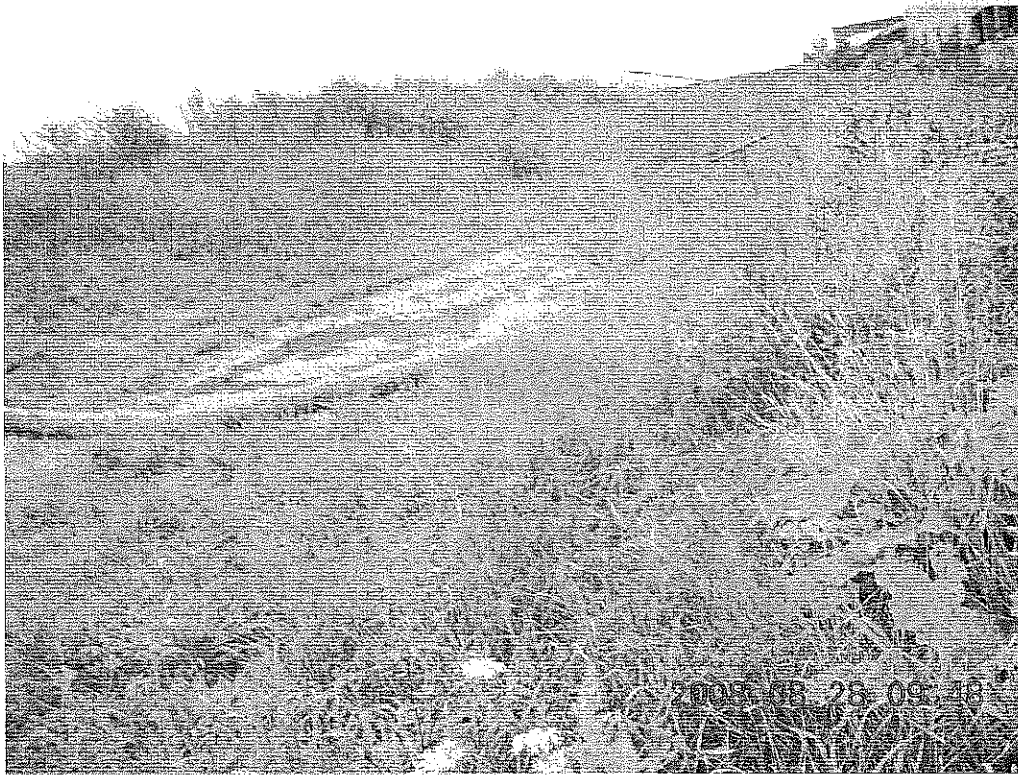
Photo 19 (DSCN 3972)

Description: Standing water located near the southwest corner of the manure holding pond.

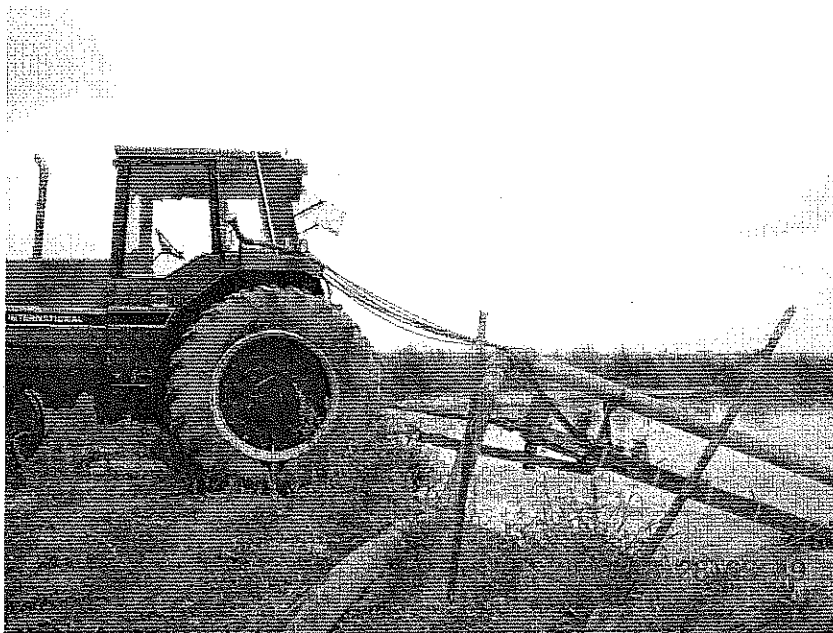
Photo 20 (DSCN 3975)

Description: Manure holding pond, right. Hose, center, is pumping liquid from the manure holding pond to Slat Barn (Slate Barn location indicated on map, Attachment A) in order to liquefy solid wastes in Slat Barn pit.

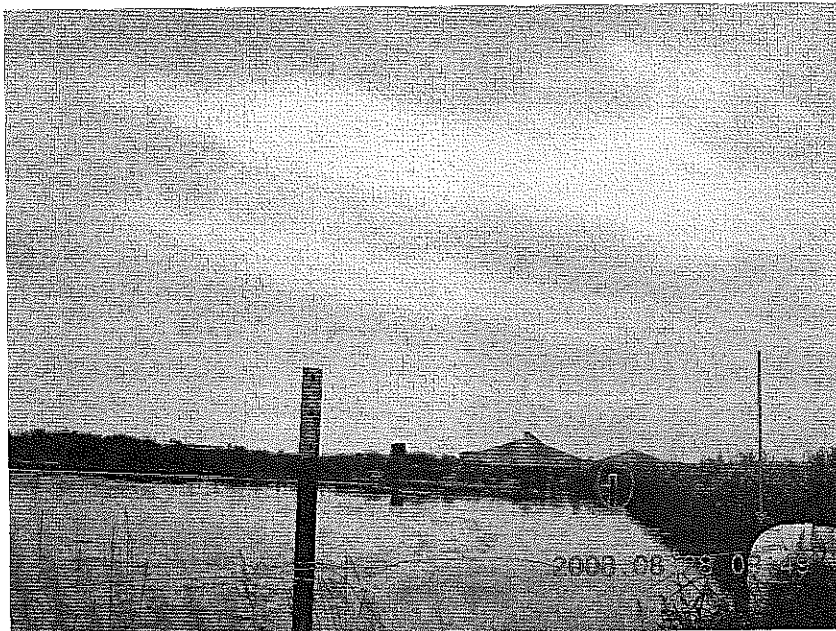
Photo 21 (DSCN 3977)

Vegetation is not maintained at a height below 6 inches above the ground on holding pond berm. Signs of erosion on the west side of the holding pond indicate that the vegetation may be too sparse to prevent erosion. Because of the height of the vegetation, EPA could not determine whether there was any damage to the berm caused by erosion, slumping or animal burrowing. At the time of inspection, there were no records included in the CNMP that noted actions taken to correct any problems with the holding pond berm. Mr. Geiger said that the liner in the holding pond was recently replaced. The facility does not record when problems with the collection system, lift stations, mechanical and electric systems, transfer stations, control structures, and pump stations are discovered or corrected.

Description: Pipe from Catch Basins 1-4 and 7, foreground, indicated by pink arrow. Pipe from Catch Basins 5 and 6, background, indicated by pink circle. Umowed vegetation along berm, background.

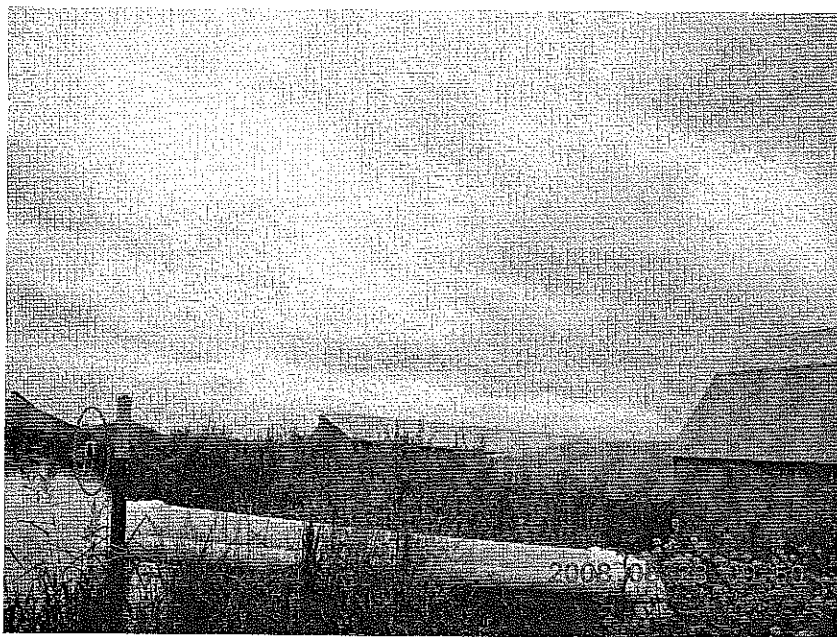
Photo 22 (DSCN 3979)

Description: Pipe from Catch Basins No.s 1-4 and Catch Basin 7, foreground. Pipe from Catch Basins 5 and 6, background, indicated by pink circle.

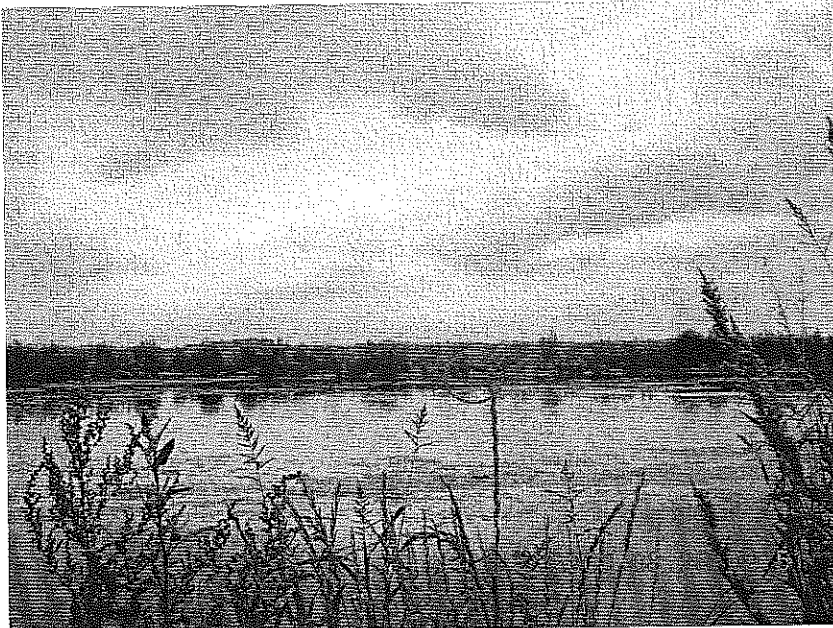
Photo 23 (DSCN 3981)

Depth gauge, center, indicated by pink circle.

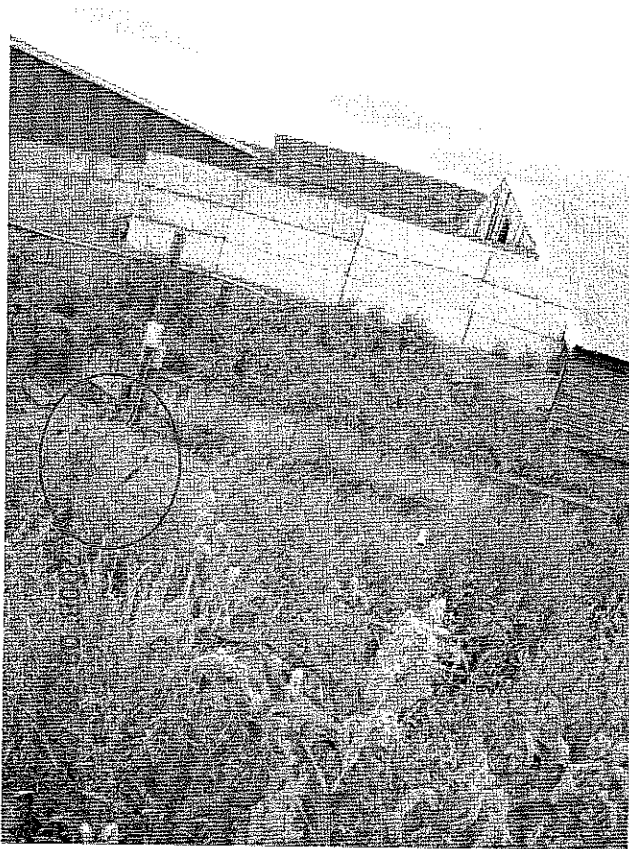
Photo 24 (DSCN 3986)

Description: Unmowed vegetation along south side of holding pond berm, foreground. Trough behind Red Barn and composting structure, background. Trough is graded towards Catch Basin 5, indicated by pink circle, which is pumped to manure holding pond.

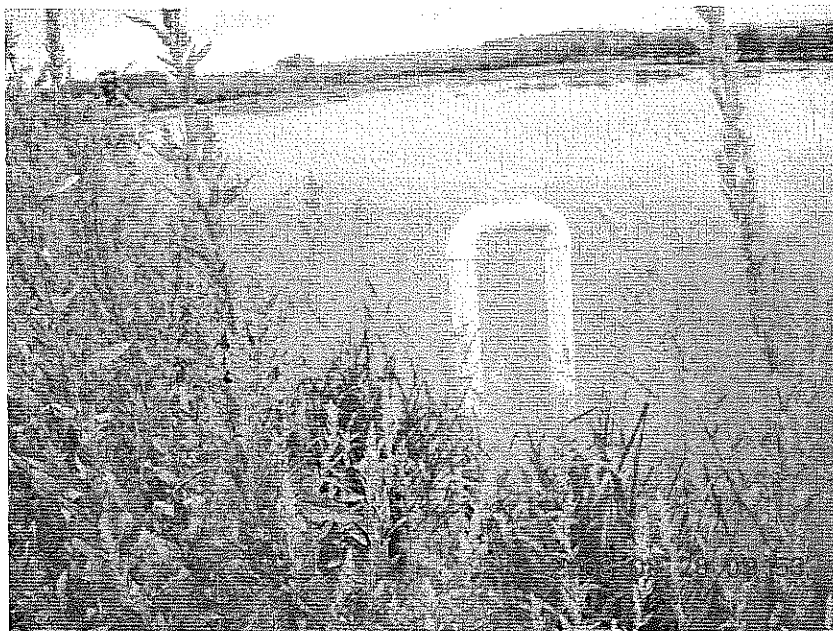
Photo 25 (DSCN 3987)

Description: Input pipe from Catch Basin 5 and 6 to manure holding pond amid unmowed vegetation along southeast corner of holding pond berm.

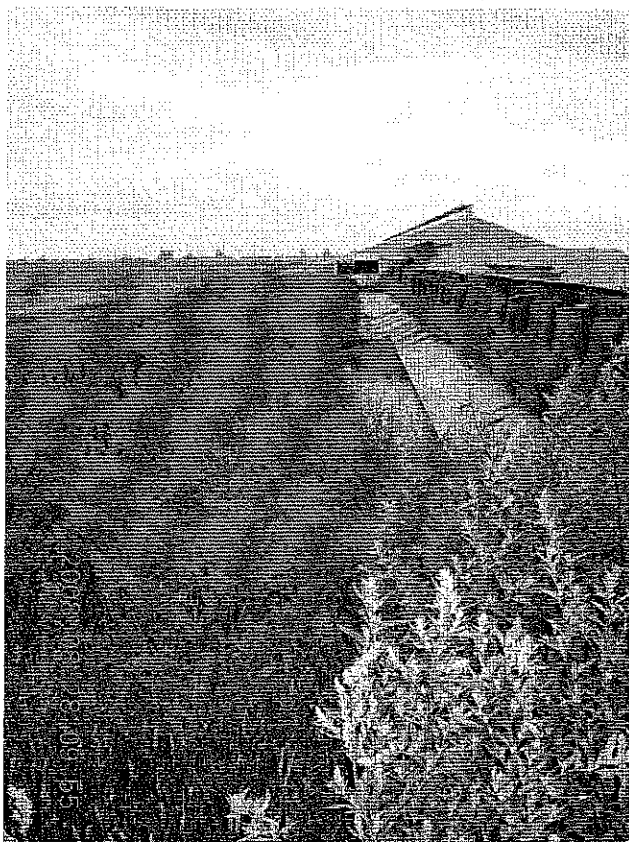
Photo 26 (DSCN 3992)

Description: Trough at the north border of the East Sector paved area catches overflow from silage bunker, right. Trough is graded towards Catch Basin 6, which is pumped to holding pond.

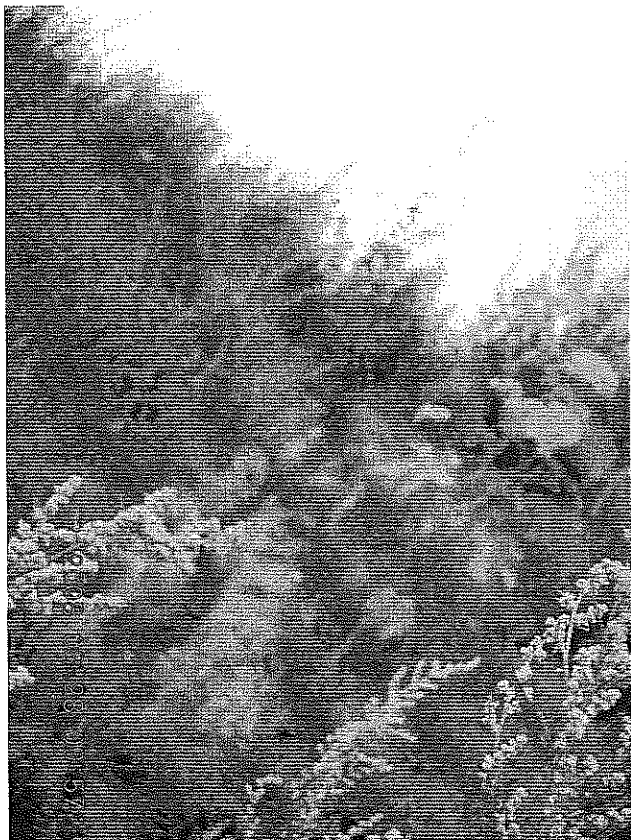
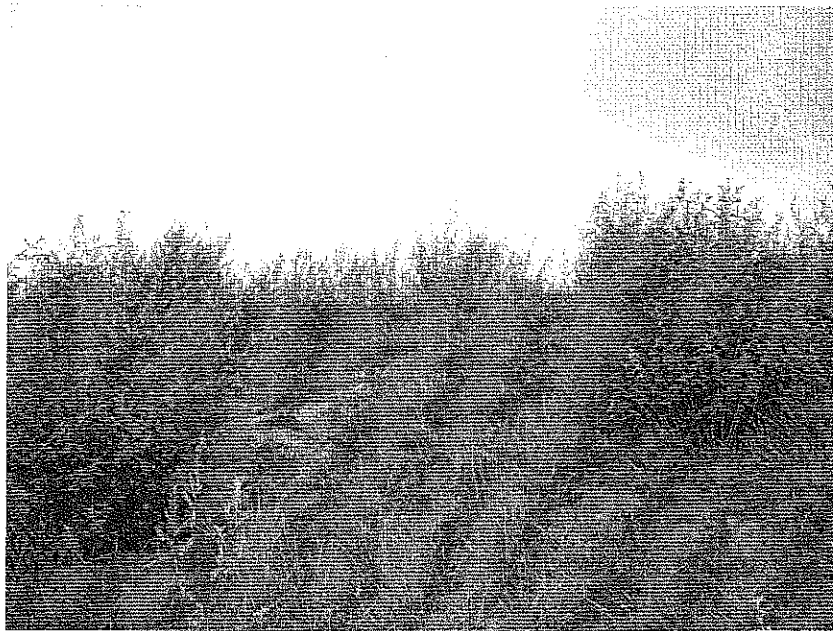
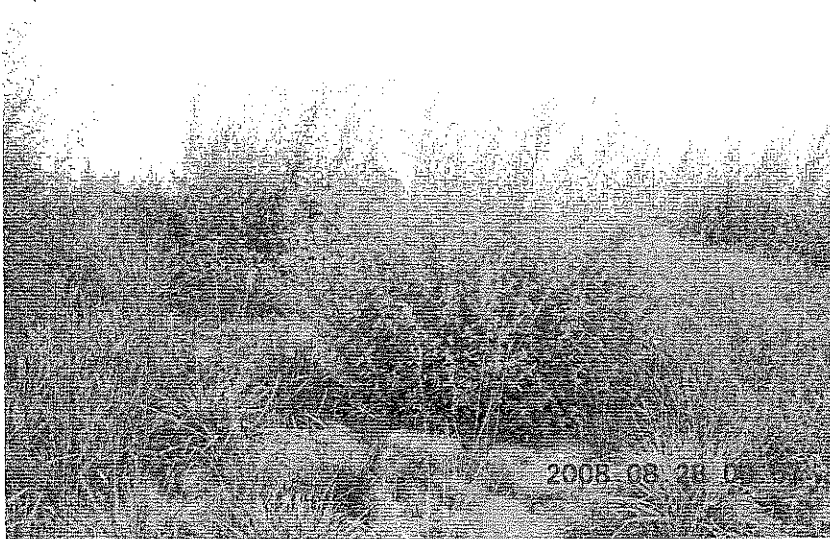
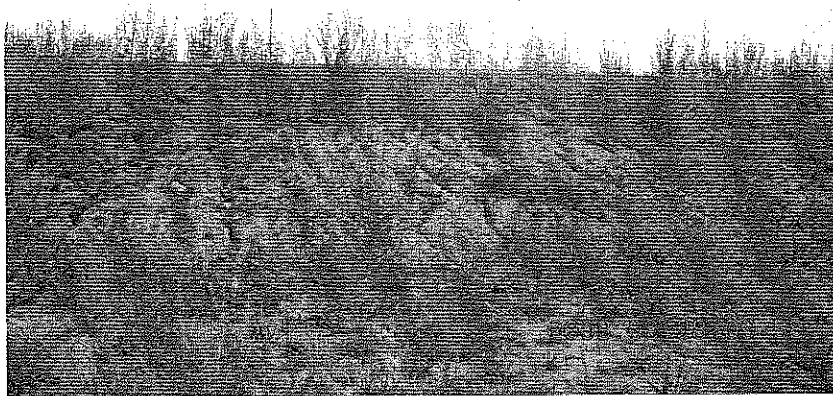
Description: Signs of erosion on west side of west holding pond berm.

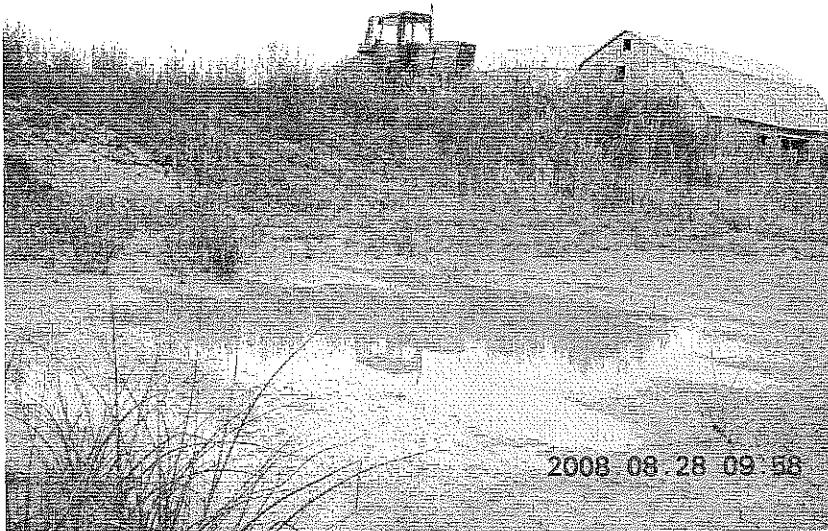
Photo 33 (DSCN 4005)

Description: Signs of erosion and standing water below the west berm of the holding pond.

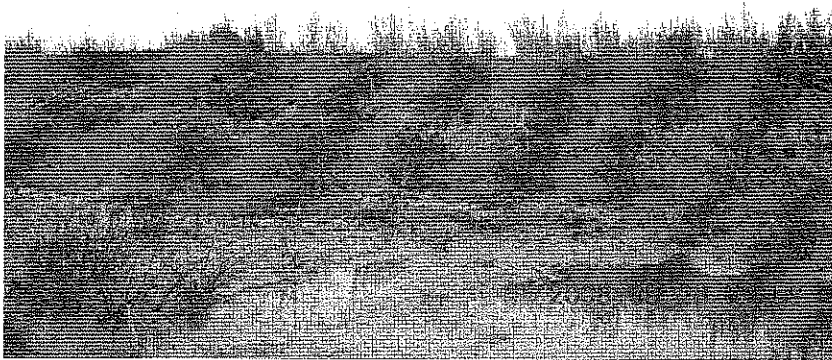
Photo 34 (DSCN 4006)

Description: Signs of erosion on and below the west berm of the holding pond.

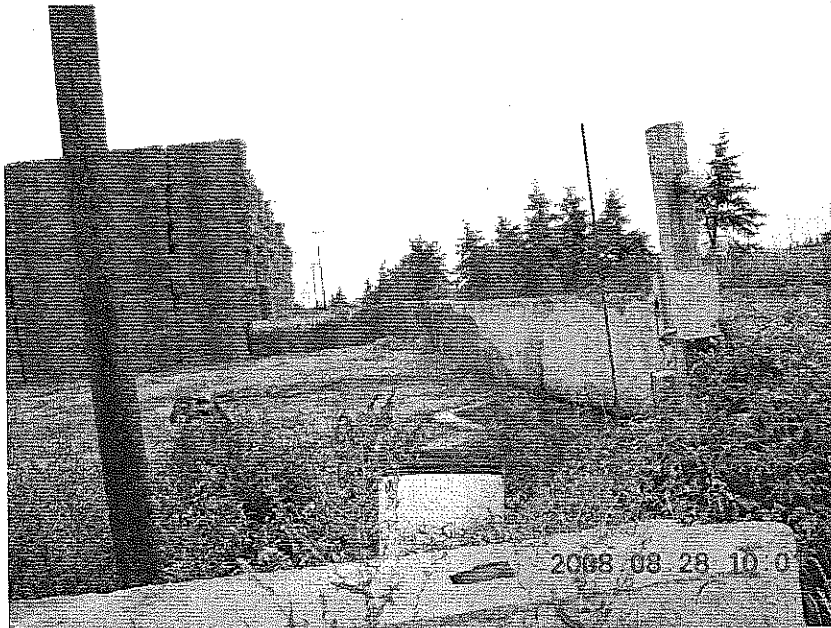
Photo 35 (DSCN 4008)

Description: Catch Basin No. 4, indicated by pink arrow, at south end of East Sector paved pad.

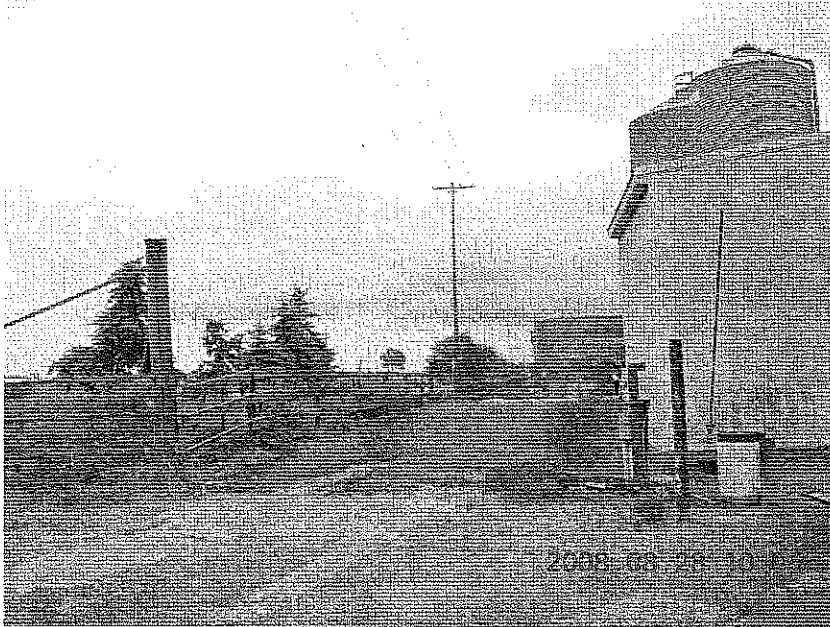
Photo 36 (DSCN 4012)

Description: Catch Basin No. 2 at south end of East Sector paved pad, right, indicated by pink arrow. Elevated driveway berm at the west side of Driveway No. 3, left.

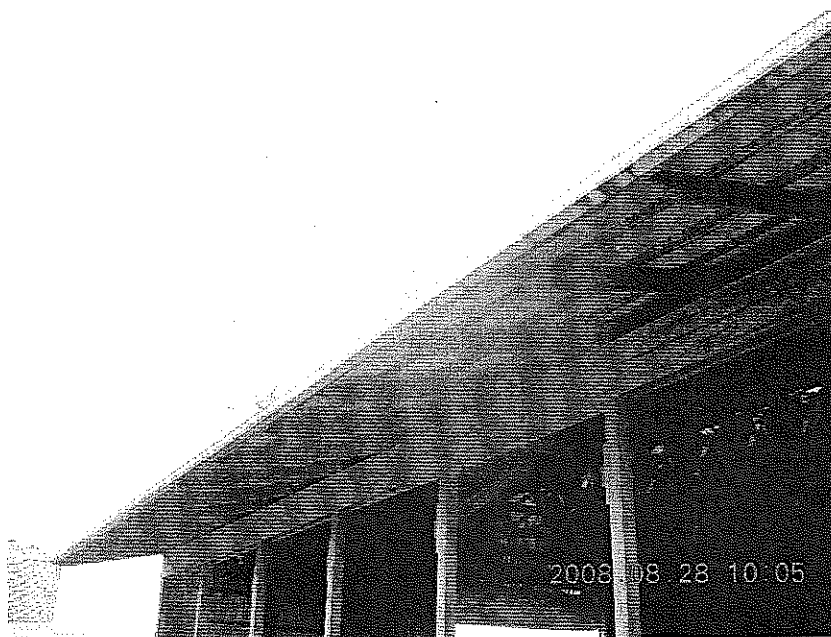
Photo 37 (DSCN 4013)

Description: Southwest corner of the Slat Barn. Storm water falls from gutters onto the East Sector paved pad, where it flows to Catch Basin No. 1.

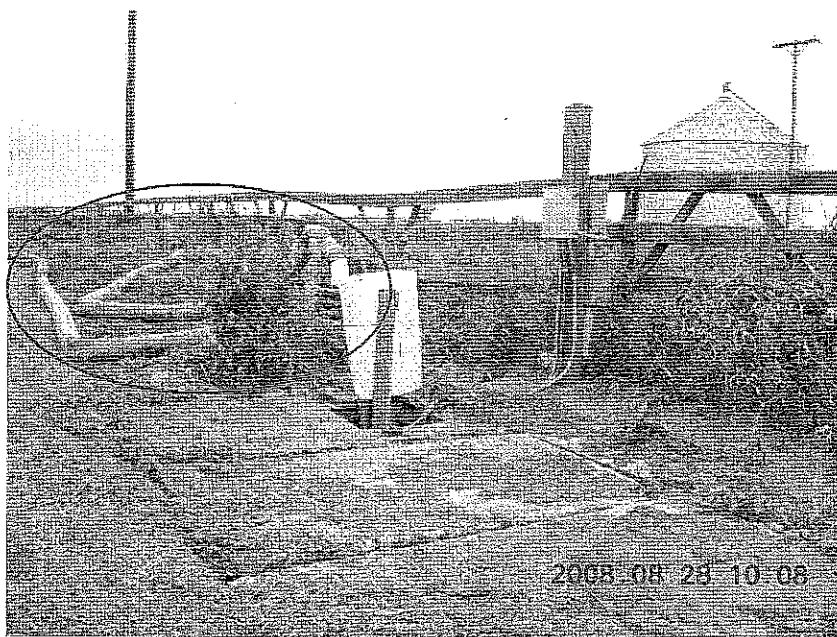
Photo 38 (DSCN 4017)

Description: Catch Basin No. 1 at south end of paved pad in East Sector. Hose (indicated by pink circle) is pumping liquid from the manure holding pond, through the catch basin, and into the Slat Barn pit for liquefying solid waste in the Slat Barn pit.

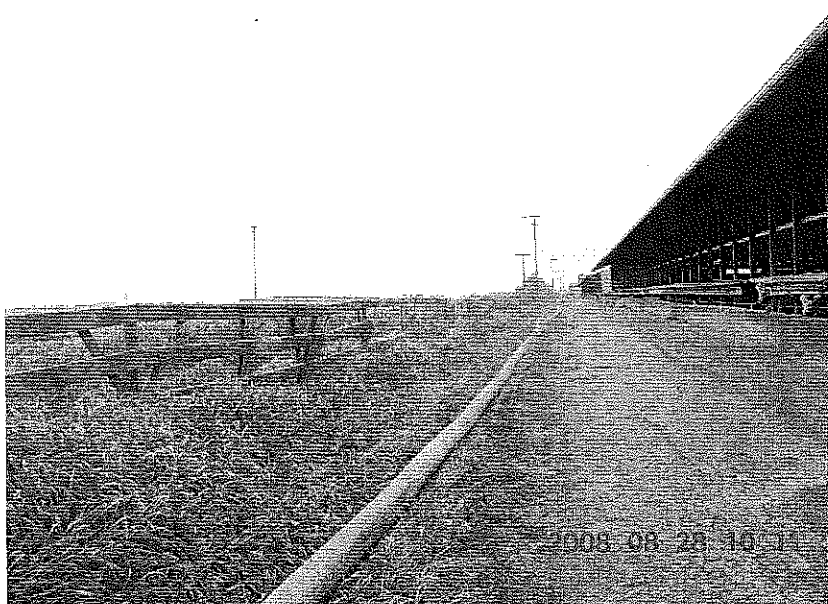
Photo 39 (DSCN 4019)

Description: Hose, center, is pumping liquid from the holding pond, through Catch Basin No. 1, and into the Slat Barn for liquefying solid waste in the Slat Barn pit.

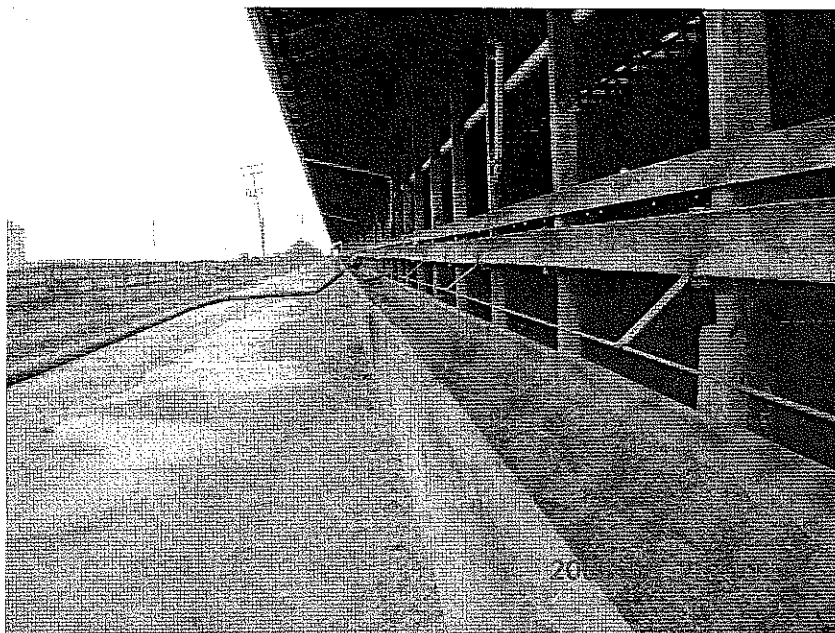
Photo 40 (DSCN 4021)

Description: Hose, left, is pumping liquid backwards from the holding pond, through Catch Basin No. 1, and into the Slat Barn for liquefying solid waste in the Slat Barn pit.

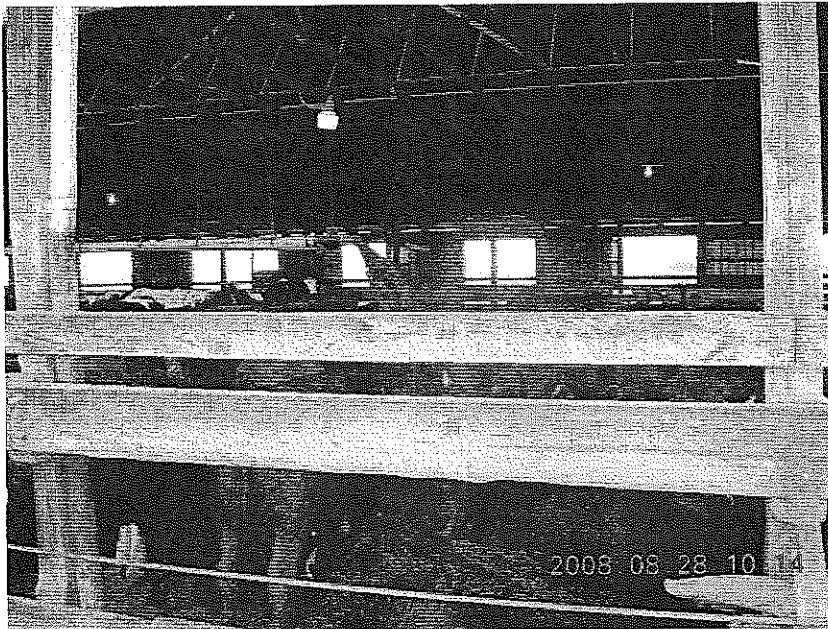
Photo 41 (DSCN 4023)

Description: Eastern end of Slat Barn. Pipe (top left, indicated by pink arrow) is pumping liquid from the holding pond and into the Slat Barn for liquefying solid waste in the Slat Barn pit.

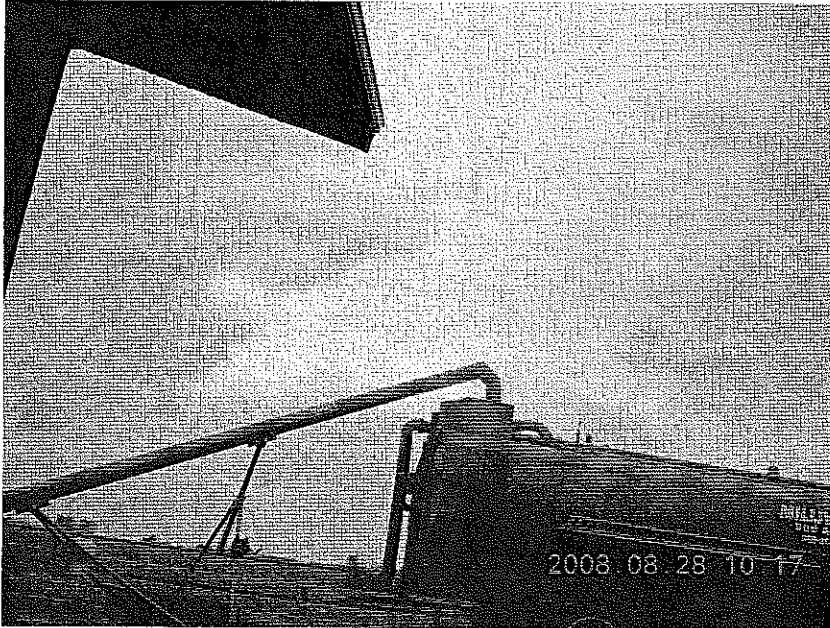
Photo 42 (DSCN 4026)

Description: Liquid manure hauler pumping manure from Slat Barn pit at eastern end of Slat Barn.

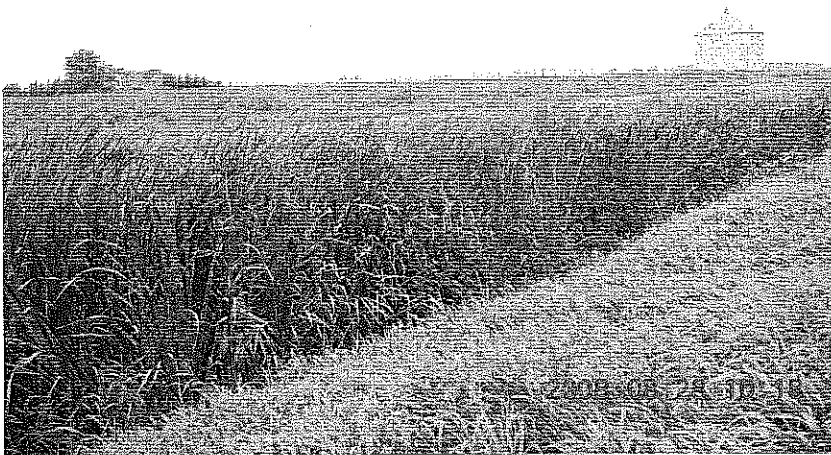
Photo 43 (DSCN 4028)

Description: Unnamed roadside ditch viewed from east end of Slat Barn. Ditch runs between Purdy Road, background, and East Sector paved pad.

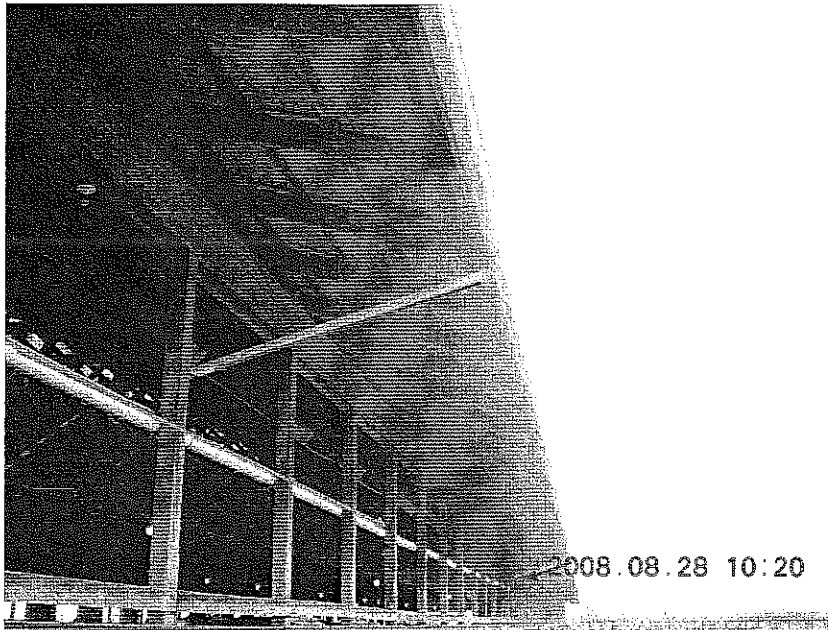
Photo 44 (DSCN 4029)

Description: South side of Slat Barn. Eave collection system connected to gutters (indicated by pink arrows) is not yet functional; instead, water falls onto pavement via holes cut in the gutter. The pipe that is visible below the gutters (indicated by green arrow) is not yet part of the system.

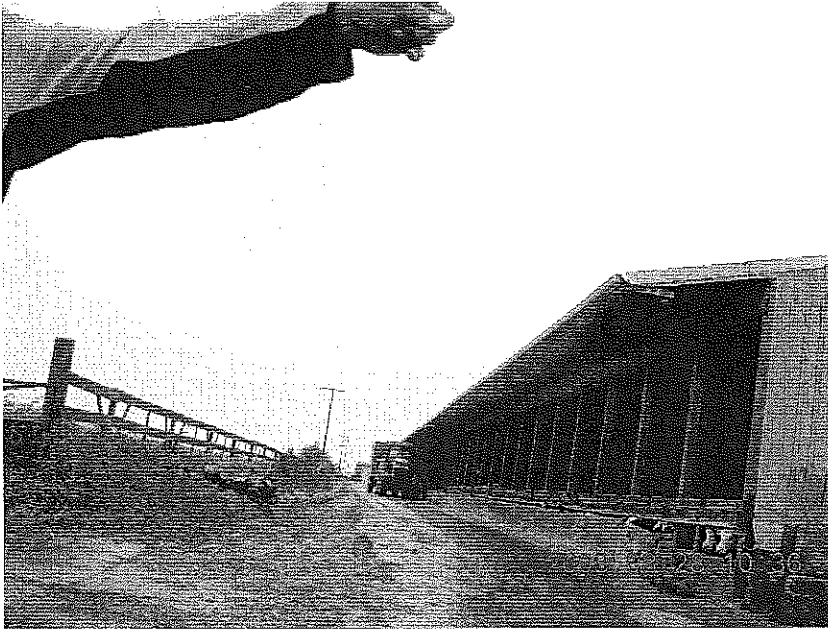
Photo 45 (DSCN 4031)

Description: Southeast corner of Slat Barn. Holes in the gutters direct storm water to the East Sector paved area, where storm water flows towards Catch Basin No. 1.

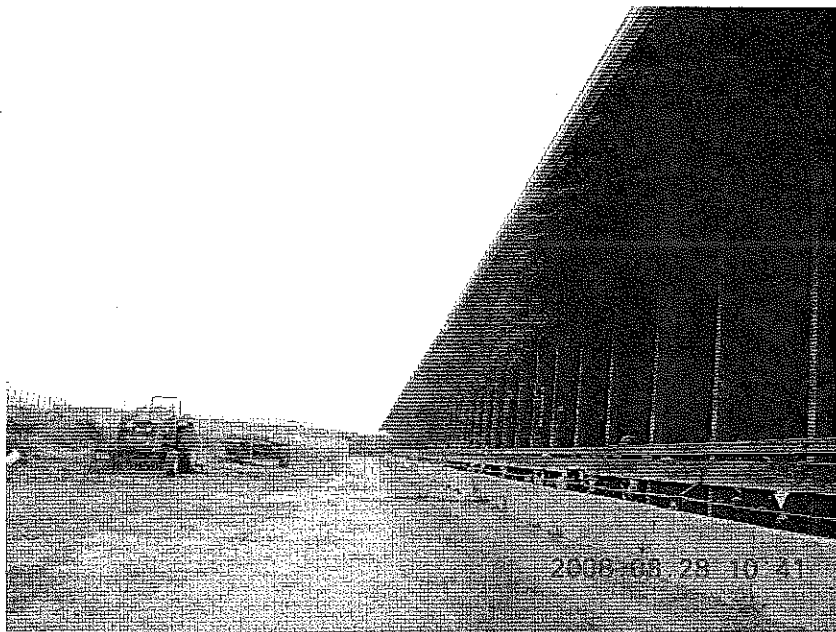
Photo 46 (DSCN 4039)

Description: South side of New Barn. Gutters direct storm water to ground, where storm water flows to Catch Basin 7.

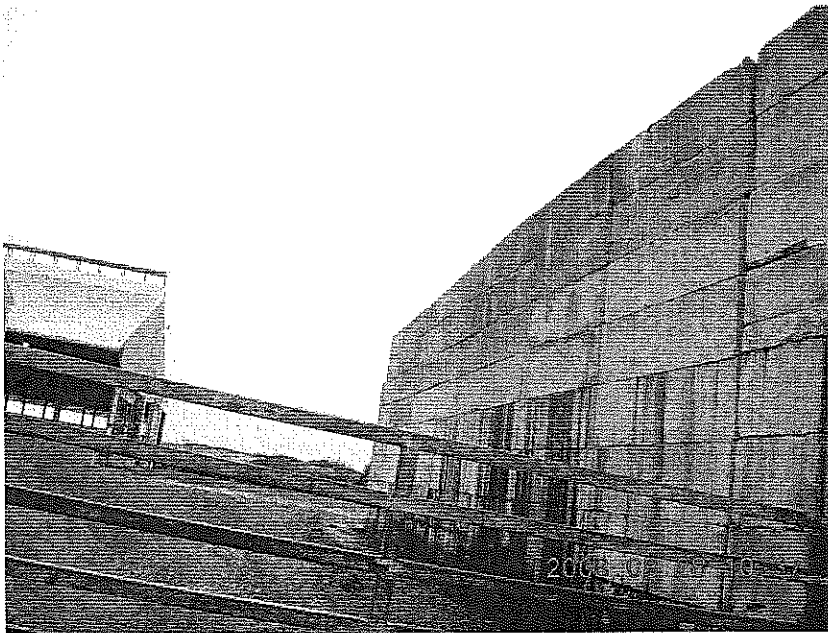
Photo 47 (DSCN 4036)

Description: New Barn, left background. Concrete compost storage structure, right foreground. Seepage from compost runs into Catch Basin 7.

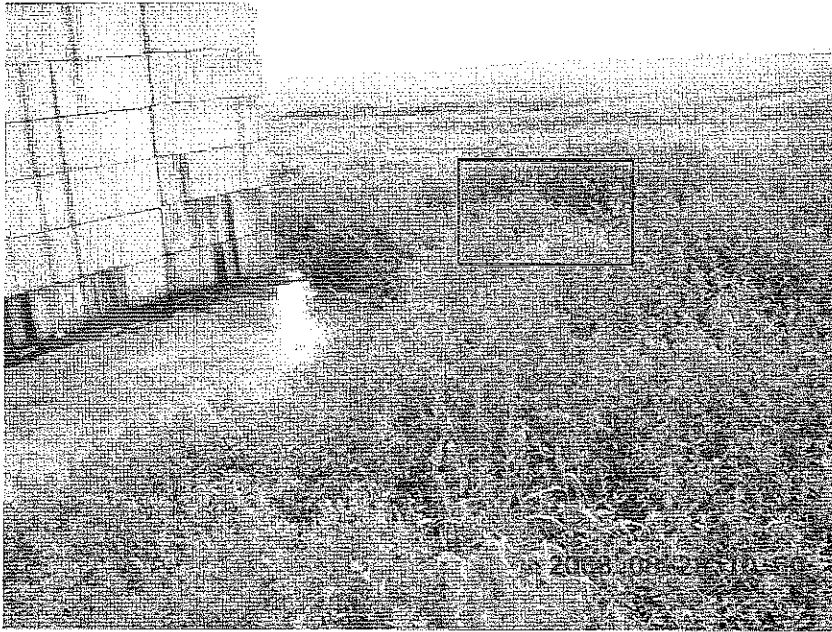
Photo 48 (DSCN 4046)

Description: Concrete compost structure on east side of East Sector, right. Seepage from compost structure runs to Catch Basin 7 just north of paved pad, indicated by pink rectangle.

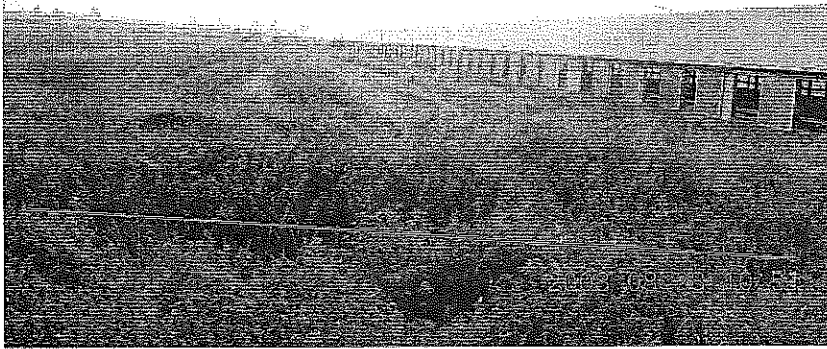
Photo 49 (DSCN 4048)

that this paved area is graded towards a catch basin (Catch Basin 7) located just east of these structures. Catch Basin 7 is connected to Catch Basin 1 via a concrete channel and a pipe. Liquid from Catch Basin 1 is automatically pumped to the holding pond (photos 48-50). No discharge or runoff pathway was observed from the concrete channel connecting Catch Basin 7 to Catch Basin 1.

Description: Trough connecting Catch Basin 7 (left, out of photo), to Catch Basin No. 1. Trough is lined with concrete, and runs where vegetation dips in the photo (location and flow direction indicated by pink arrow). North side of Slat Barn, right background.
